# Hans van Heeswijk

## Uitbreiding en renovatie Mauritshuis Mauritshuis Extension and Renovation

Plein 29  
Den Haag/The Hague

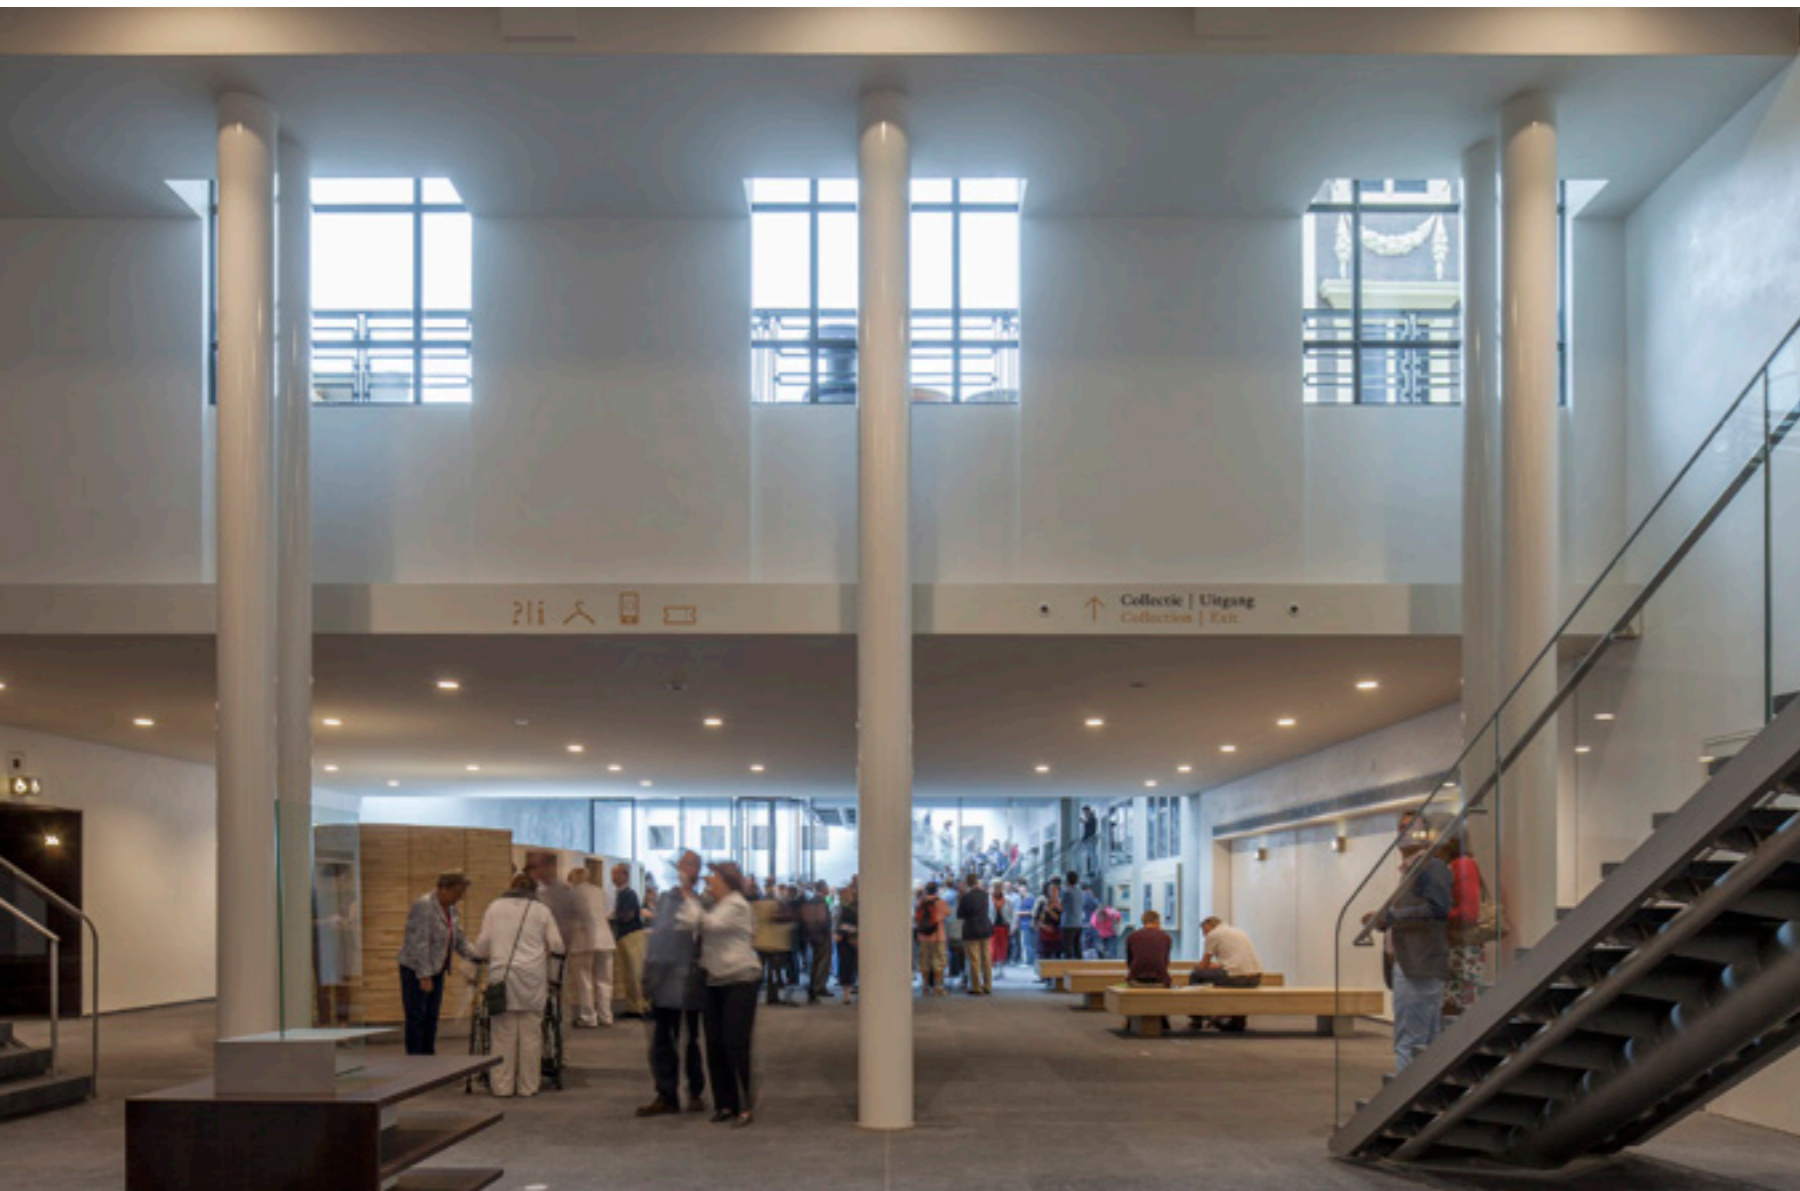
Whereas in the past visitors entered the museum via the service entrance at the side of the building, they now descend via a steel stair or glass lift on the left side of the forecourt whereupon the foyer is revealed through a large glass wall. There is no sense here of being underground thanks to the size of the space and the fact that daylight enters in several places. The new entrance makes orientation and the logistics of the entrance zone perfectly clear: immediately to their left visitors can take either of two stairs or a lift to enter the museum. The lift emerges into a glazed porch-cum-lift shaft right behind the front door of the former residence, thereby effectively reinstating the original entrance. The glass lift and free-standing steel stairs were specially designed for the extension.

Voorheen betraden bezoekers het museum via de dienstingang aan de zijkant van het gebouw. Het publiek daalt nu aan de linkerkant van het voorplein af via een stalen trap of glazen lift. De foyer ontvouwt zich vervolgens aan de bezoekers door een grote glazen gevel. De ruimte oogt nergens ondergronds door de afmetingen en doordat het daglicht op verschillende plekken naar binnen valt. De nieuwe toegang maakt de oriëntatie en het logistiek gebruik van het entreegebied zeer helder: meteen links kunnen bezoekers met twee trappen of met een lift het museum betreden. De lift arriveert bovendien in een glazen tochtportaal annex liftschacht direct achter de oorspronkelijke voordeur van het voormalige woonhuis, waardoor de originele entree als het ware in ere is hersteld. De glazen liften en vrijstaande stalen trappen zijn speciaal voor de uitbreiding ontworpen.

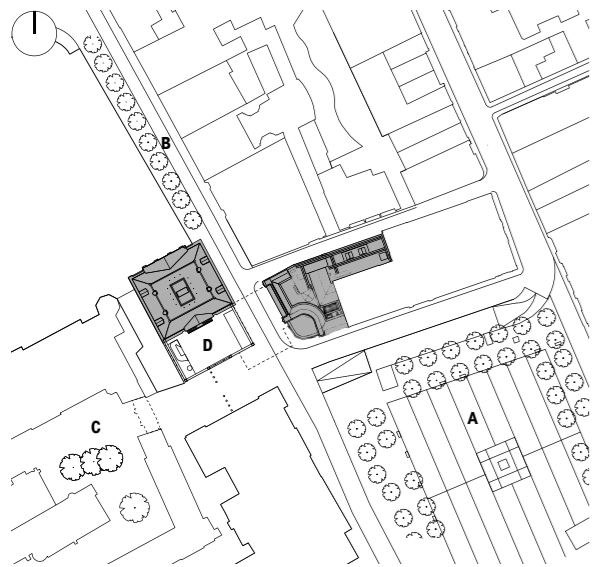
**Situatie/Site plan**

- A Plein
- B Korte Vijverberg
- C Binnenhof
- D Mauritshuis

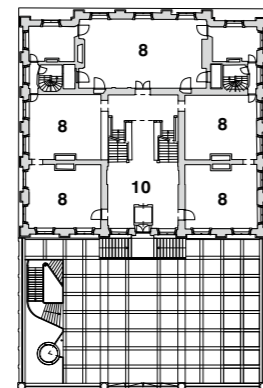
**Tweede, eerste verdieping, begane grond, souterrain/**

**Second, first, ground floor, basement**

- 1 hoofdentree/main entrance
- 2 foyer
- 3 receptie/reception
- 4 museumwinkel/museum shop
- 5 entree naar/entrance to museum
- 6 entree naar Royal Dutch Shell Vleugel/entrance to Royal Dutch Shell Wing
- 7 brasserie
- 8 tentoonstellingszaal/exhibition room
- 9 lezingenzaal/lecture theatre
- 10 hal/hall
- 11 bibliotheek/library
