Hans van Heeswijk

Uitbreiding en renovatie Mauritshuis Mauritshuis Extension and Renovation

Plein 29
Den Haag/The Hague

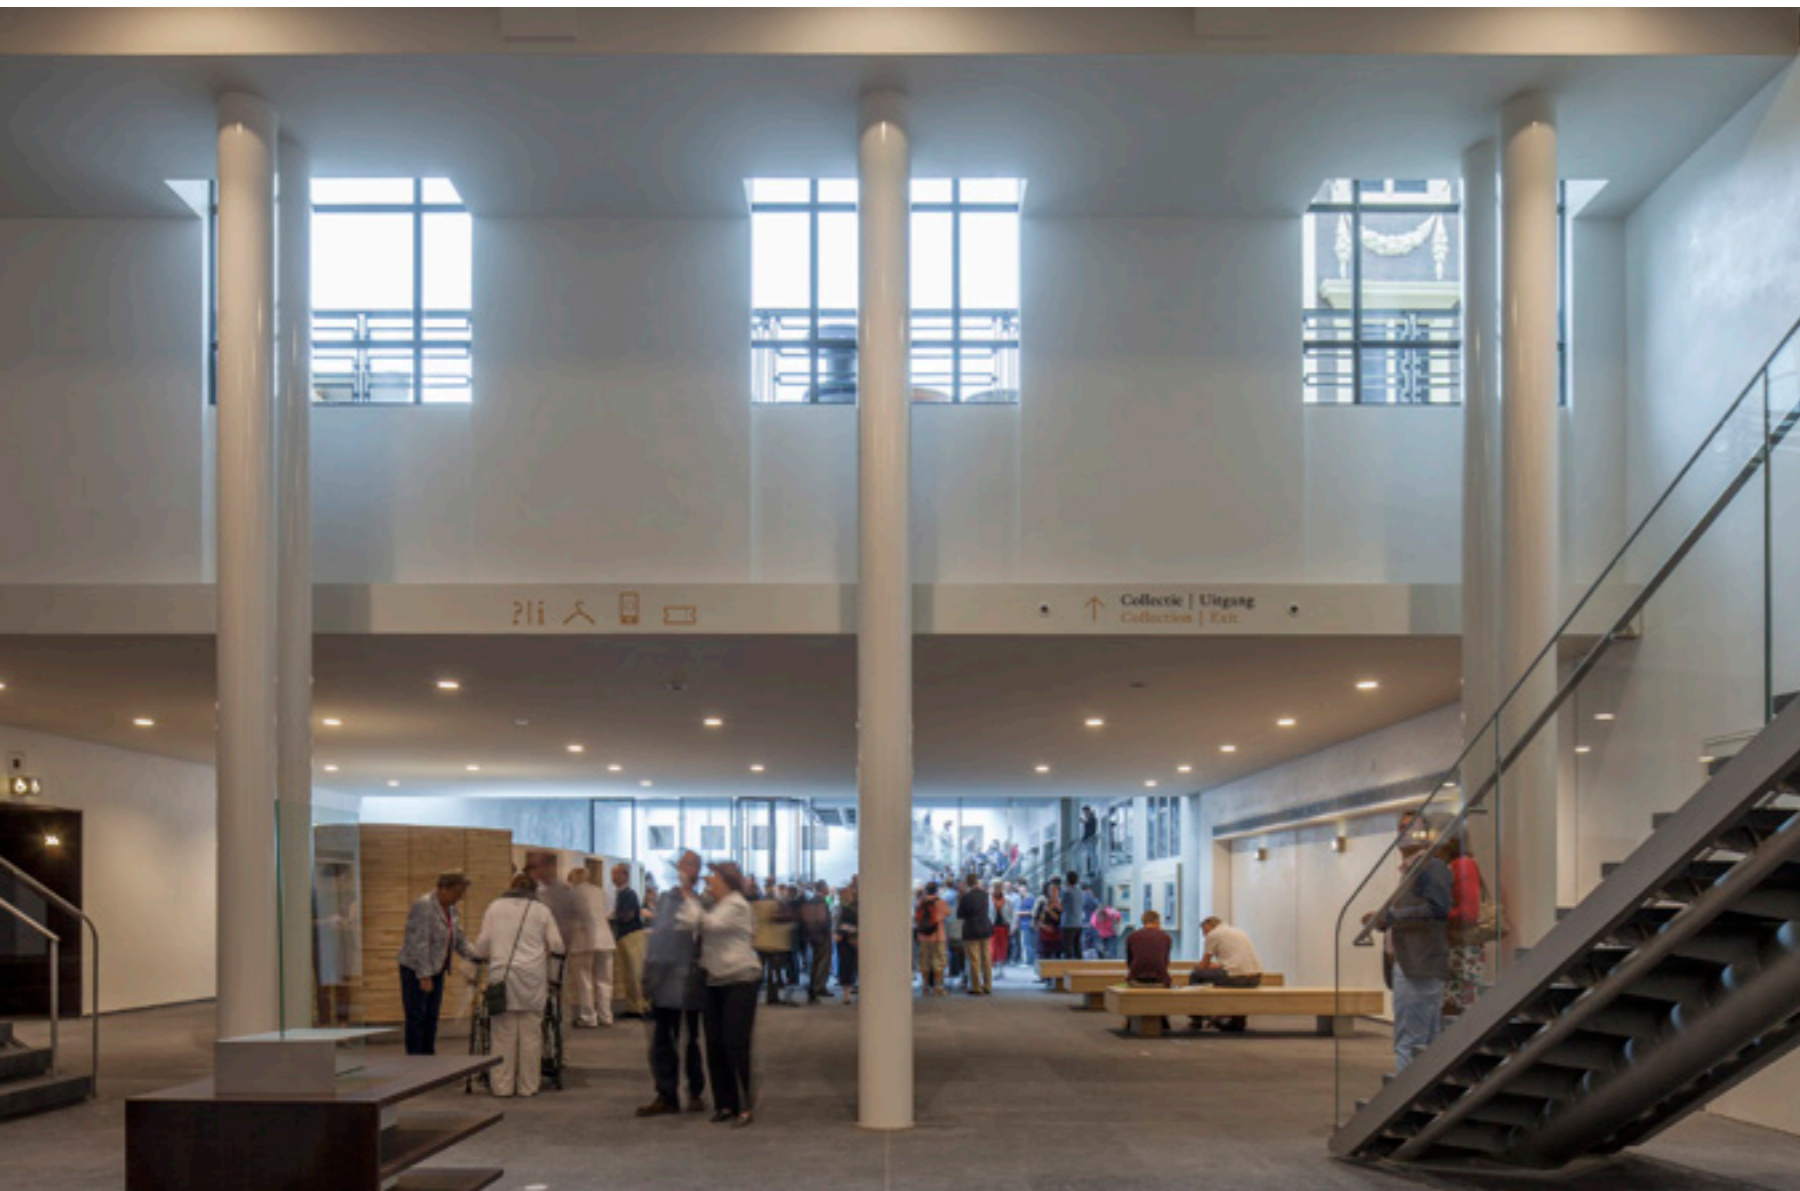
Voorheen betraden bezoekers het museum via de dienstingang aan de zijkant van het gebouw. Het publiek daalt nu aan de linkerkant van het voorplein af via een stalen trap of glazen lift. De foyer ontvouwt zich vervolgens aan de bezoekers door een grote glazen gevel. De ruimte oogt nergens ondergronds door de afmetingen en doordat het daglicht op verschillende plekken naar binnen valt. De nieuwe toegang maakt de oriëntatie en het logistiek gebruik van het entreegebied zeer helder: meteen links kunnen bezoekers met twee trappen of met een lift het museum betreden. De lift arriveert bovendien in een glazen tochtportaal annex liftschacht direct achter de oorspronkelijke voordeur van het voormalige woonhuis, waardoor de originele entree als het ware in ere is hersteld. De glazen liften en vrijstaande stalen trappen zijn speciaal voor de uitbreiding ontworpen.

Whereas in the past visitors entered the museum via the service entrance at the side of the building, they now descend via a steel stair or glass lift on the left side of the forecourt whereupon the foyer is revealed through a large glass wall. There is no sense here of being underground thanks to the size of the space and the fact that daylight enters in several places. The new entrance makes orientation and the logistics of the entrance zone perfectly clear: immediately to their left visitors can take either of two stairs or a lift to enter the museum. The lift emerges into a glazed porch-cum-lift shaft right behind the front door of the former residence, thereby effectively reinstating the original entrance. The glass lift and free-standing steel stairs were specially designed for the extension.

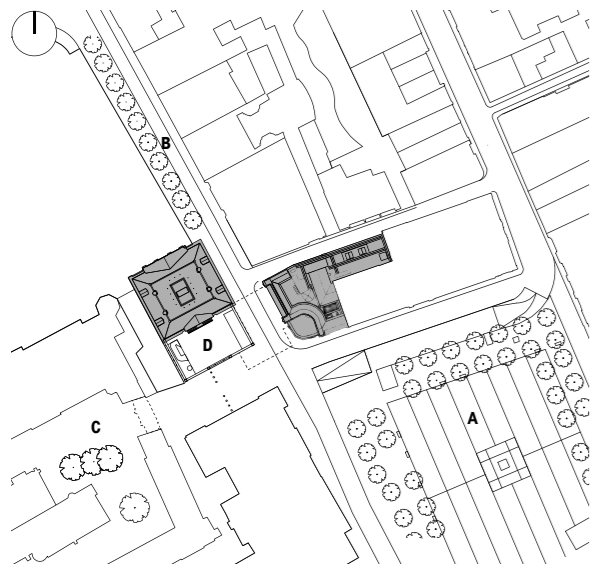
Situatie/Site plan

- A Plein
- B Korte Vijverberg
- C Binnenhof
- D Mauritshuis

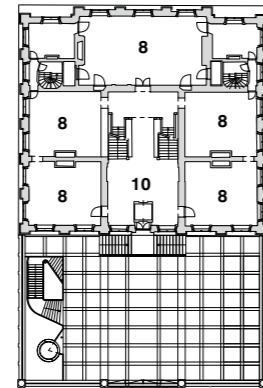
Tweede, eerste verdieping, begane grond, souterrain/

Second, first, ground floor, basement

- 1 hoofdentree/main entrance
- 2 foyer
- 3 receptie/reception
- 4 museumwinkel/museum shop
- 5 entree naar/entrance to museum
- 6 entree naar Royal Dutch Shell Vleugel/entrance to Royal Dutch Shell Wing
- 7 brasserie
- 8 tentoonstellingszaal/exhibition room
- 9 lezingenzaal/lecture theatre
- 10 hal/hall
- 11 bibliotheek/library
